Manhole Inspection Summary

Manhole # S27M__014MH

Insp Date: **5/13/08 8:58 AM**

Location Address: **behind 601 Archer St**

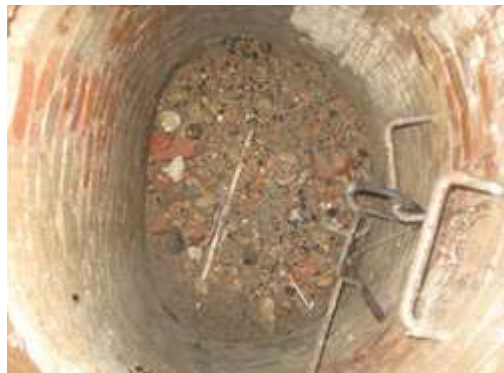
Top View

Condition: ☐ Sound ☐ Cracked ☐ Root Intrusion ☐ Deteriorated ☐ Leaks ☒ **Debris**

debris on base / channel

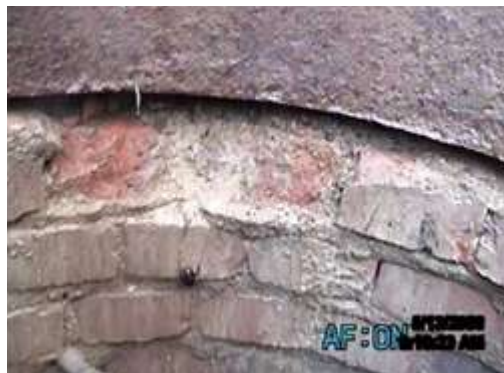
Defect 3

Condition: ☐ Sound ☐ Cracked ☐ Root Intrusion ☐ Loose Brick ☒ **Deteriorated**

chimney cond deteriorated

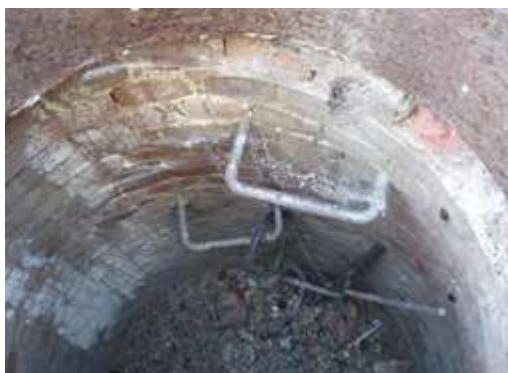
Defect 1

Infiltration: ☐ None ☐ Joint ☐ Cracks ☒ **Mortar** ☐ Roots ☒ **Wall**

chimney mortar, chimney flow wall,
bench and channel debris

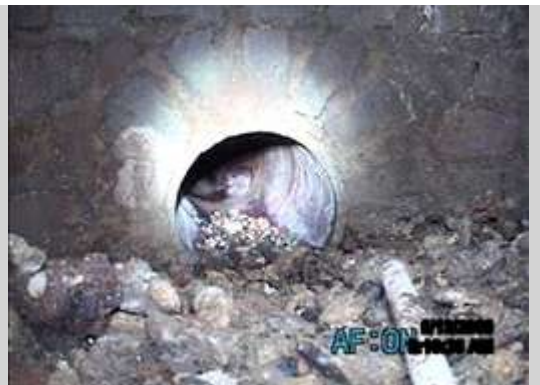
12 O'Clock Outflow

8 in. Circular Gravity Sewer
Pipe Out @ 12 O'Clock

Infiltration: **None** Pipe Seal Cond: **Sound**
